REPORT NO. MR 34

AN INVESTIGATION OF SLOPE FAILURES  
IN THE NORTHERN PART OF THAILAND

DEPARTMENT OF HIGHWAYS , MINISTRY OF COMMUNICATIONS ,  
BANGKOK 4, THAILAND

Report No. 34  
Materials & Research Division  
Department of Highways  
June 1978

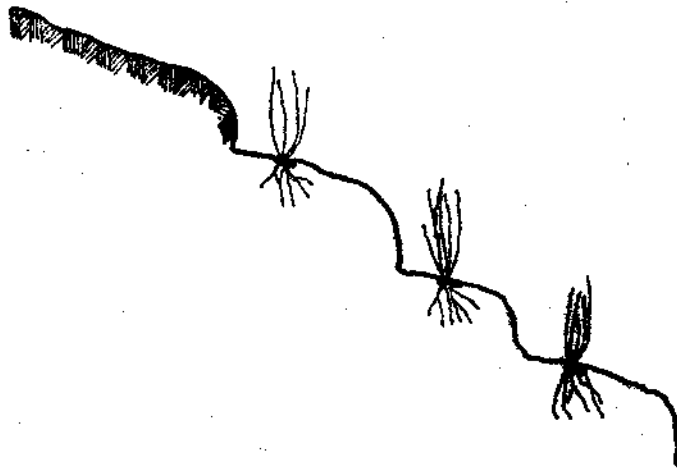
FIG. 1. GRASS GROWING CONDITION

Growing of grass was done by cutting the side slope into small steps and the sprigs of grass were grown at a distance apart as shown in to Figure 1. The condition of grass growing will be able to slowdown running water on the slope surface and stabilize the soil surface and thus prevents surface scouring, but the slowed down running water will be able to have chance to penetrate down into the side slope since the soil surface is still opened and the running speed is low. At the two

stations, grassing by this method was done only at the top part, about one third, of the side slopes. The surface of the lower part or the bottom part of the side slopes is a bare soil surface. It should be remarked here that both types of surfaces, the surfaces with and without sprigging of grass, cannot prevent penetration of water through them.

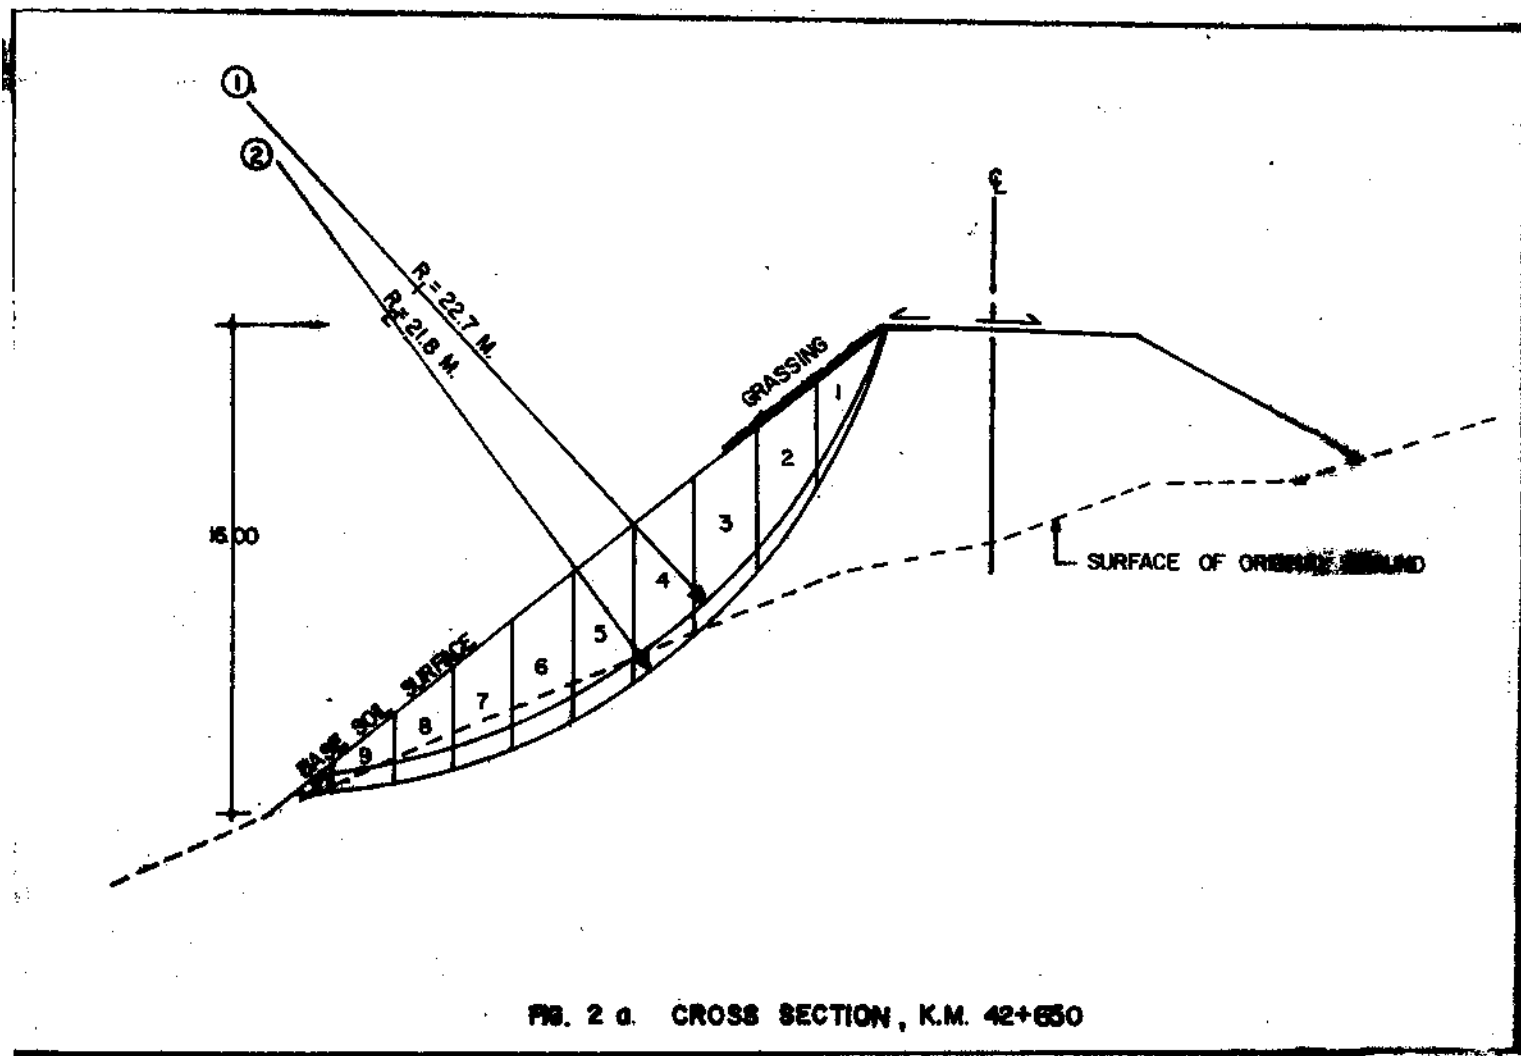
Cross sections of the road as designed are shown in Figure 2. It can be seen that at both stations, the road surface slopes down in the opposite direction of the failed side slope. However slope of the shoulder next to the side slope does have the same direction with the side slope. Concrete lining side slope to catch water from the attached hill side and the road surface. At the two stations, the embankments laying on sloping original grounds are about 16 meters high at Km. 42+650 and 21 meters high at Km. 44+100. The side slope of the embankments is 1.25 : 1 which is rather steep for such high embankments. Geometric alignments is a combination of horizontal and vertical curves. The vertical grades are 15 percent at Km. 42+650 and 6.057 percent at Km. 44+100.

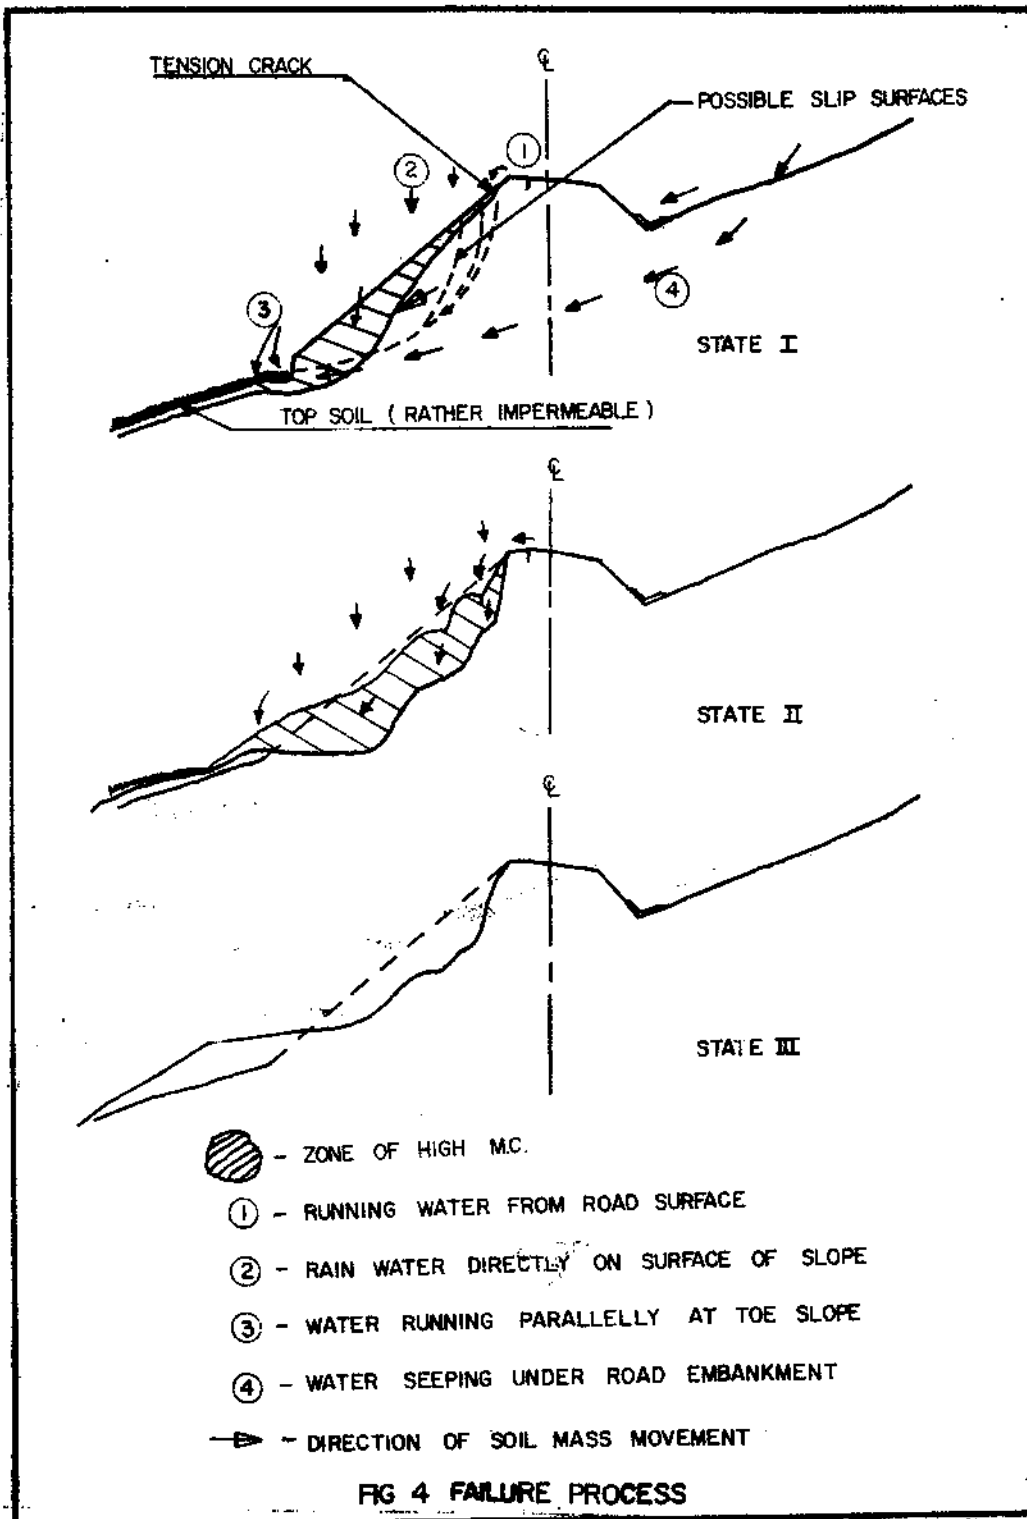
Assumption of failure of the two stations can be explained as follow. Failure of the side slopes is expected to be mainly due to the instability of the side slope. Surface scouring is also expected to occur at the bare soil surface part of the side slope especially at the toe slope, but the scouring is not the main affect of the slope failure since the scouring will be occurred by surface water No.(1) and (2) in which amount of the waters is small in comparison with the surface water No. (3), and a part of the waters will penetrate into the side slope. The instability of the side slope can be easily reached since the slope is rather high and it is not in good stable condition as explained in the section of the stability analysis. Reduction of the slope stability can be caused by reduction of soil strength at toe slope and erosion of soil mass at the area. It is expected that

a part of the waters nos. (1), (2) & (3) percolated into the side slope and were collected at the toe slope, and thus reduce the soil strength at the area. The soil mass at the toe slope can be mainly eroded by surface water No.(3). As the state of instability is reached, movement of a soil mass at the vicinity of the slope will occur along a slip surface and thus causes tension cracks at and near the slope crest as presented in the state I of the Figure 4. Number of cracks are always observed since movement of soil mass always progressed occur. Cracks can also be seen at the road surface. After cracks are formed, a certain amount of waters nos. (1) and (2) can be able to penetrate into the side slope through the cracks. The area is then softened. While the side slope is soft, the seeping water which seeps parallelly to the slope surface will be able to push mass of soil around the cracks down as presented in state II of the Figure 4. After the soft part of the soil at the side slope is pushed away the remaining part will be as shown in the state III. The soil that is pushed to the toe slope will be washed away after ward.
