EMBANKMENT FAILURES OF
LAMPANG-DENCHAI HIGHWAY CONSTRUCTION PROJECT

Report No. 47
Materials & Research Division
Department of Highways
December 1979

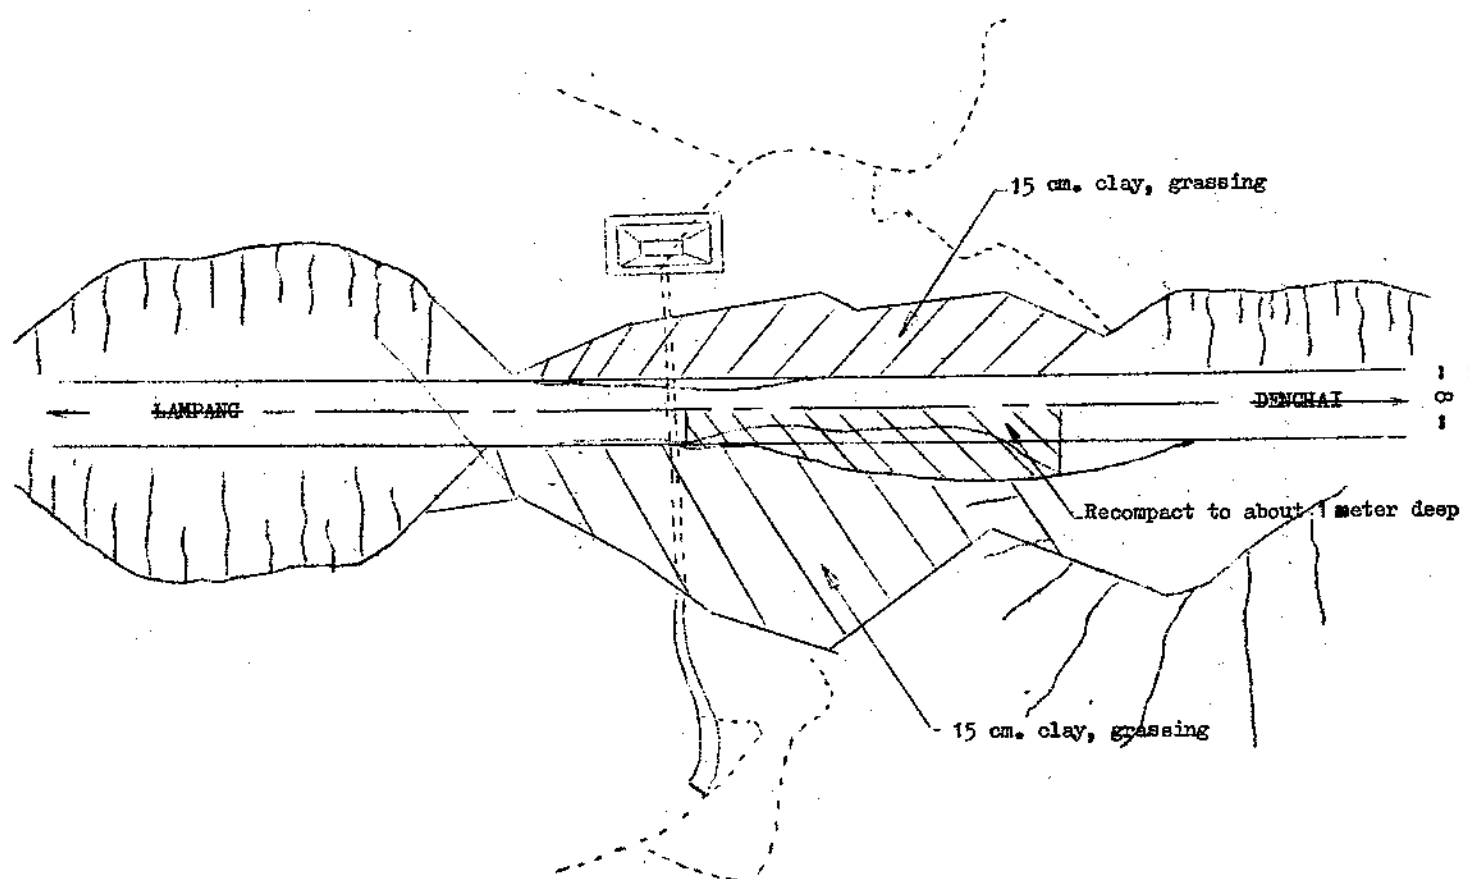
(NOT TO SCALE)
 Fig. 1a
 Station 34+860-34+920

-- Station 34/860 - 34/920. (Figs. 1a and 1b). The station shows crack and settlement at the right hand side of the embankment. The portion of the embankment is at the stream way, and it is expected to be effected by the part of water that can not get into the cross - pipe and seep through. Reduction of the soil strength and the seepage force induce the movement of the embankment. The improvement is proposed by recompacting the top part of the embankment to the depth of about one meter to eliminate the crack, covering the side slope surfaces to prevent the water seeping into the embankment, covering the ground area of

the high water side introduce the sediment pond, repairing the joints of the original pipes, and the gutter to carry the water from the outlet end of the pipe away from the toe slope. At this location the protection is not so tight since the amount of the flow is expected to be low.

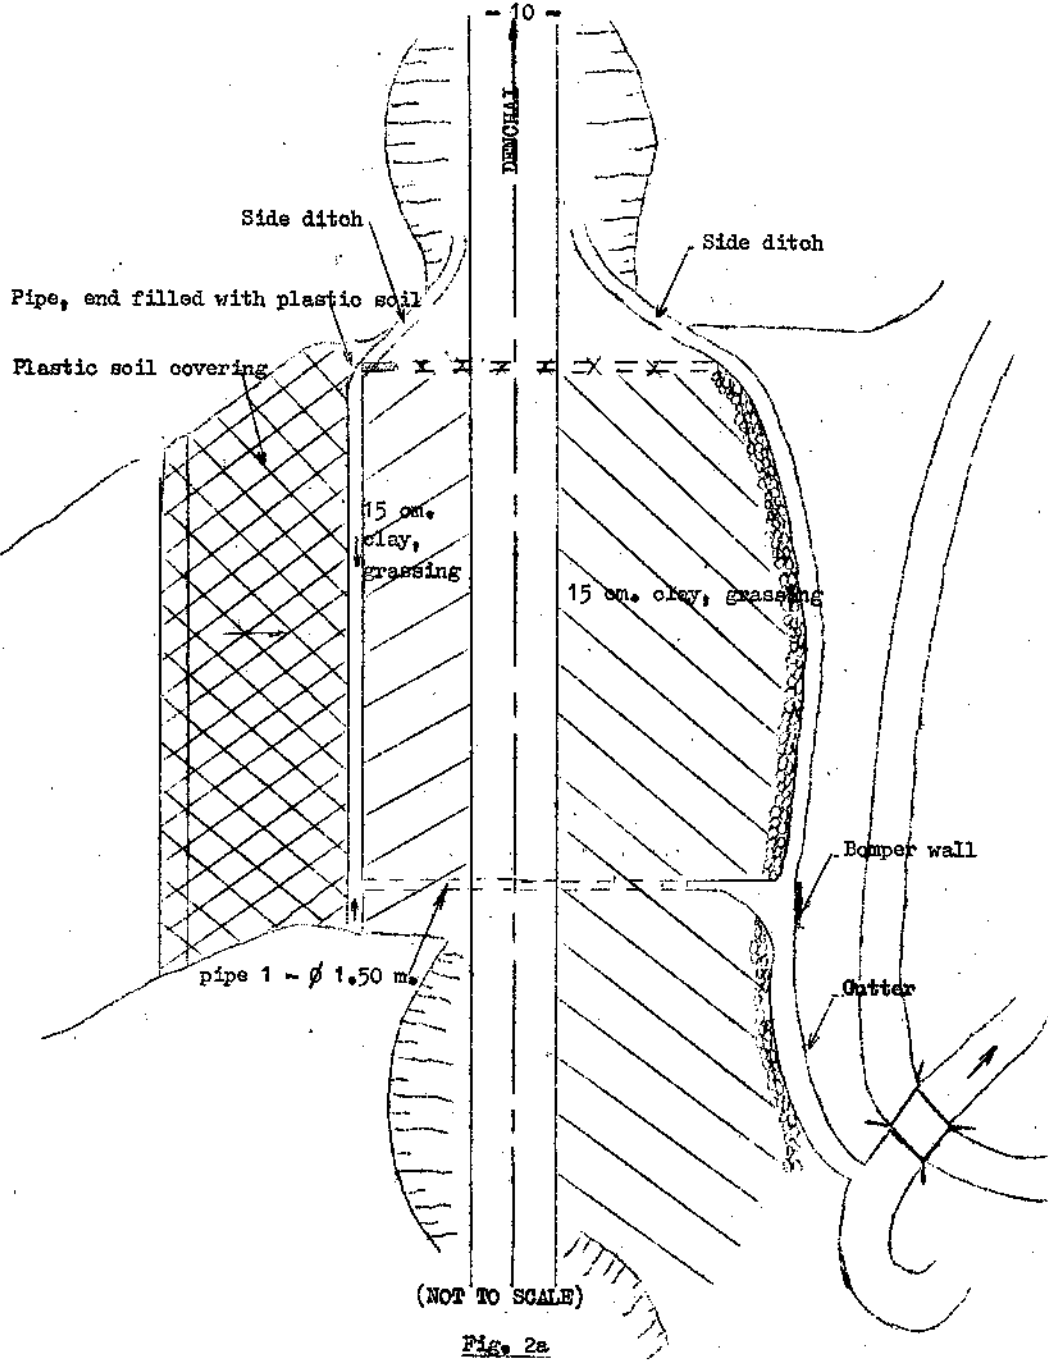
Fig. 2a

- Station: 35+576 (Figs. 2a and 2b). This location seems to be the most difficult one for improving since the problem is due to the deep under ground water and the height of the embankment which is very high, about 14 meters. It is found from the investigation that the big area of the mountain valleys was filled up to about half of the total embankment height and the filled materials is rock and granular soils which is highly permeable and can be a water collector. It is also found that the original drain - pipes is not capable for the cross drainage and partly damaged. The cause of the embankment movement, forming cracks consequently, is expected to be due to the seepage of the water in the collector through the embankment. In the design, the plastic soil trench at the left hand side is used to prevent the seeping water. Both sides of the slopes are protected by the clay and grassing. A new pipe is assigned at another location to reduce the distance of the outlet flow. A layer of sand - rock is recommended at the tail side to allow free flow of the under ground water that may leak through the soil trench. Recompaction of the embankment is recommended only for the top one meter layer only.

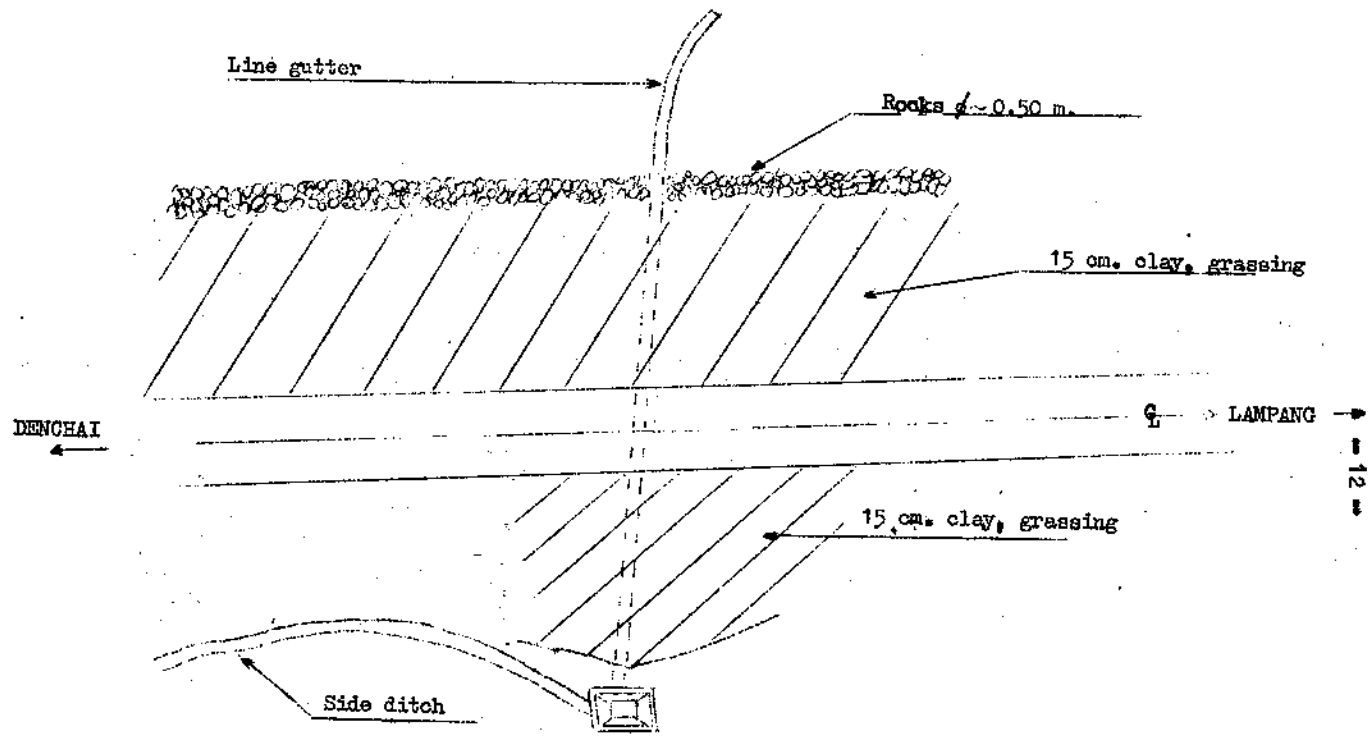
Fig. 3a

- Station 36+785 (Figs. 3a and 3b). At this location the movement is expected to be mainly caused by the softening and scouring at the toe slope of the right side of the embankment. Seepage of the Water through the embankment is an additional cause. Preventing of the seeping water is also done by protecting the side slopes, introducing sediment pond and recommending for repairing of the pipe joints. To prevent the softening and scouring of the toe slope, the embankment soil at the toe is replaced by the plastic soil aggregate, and covered with clay - grassing and a layer of big rocks. The top of the embankment is recompact to eliminate crack and to level it up.

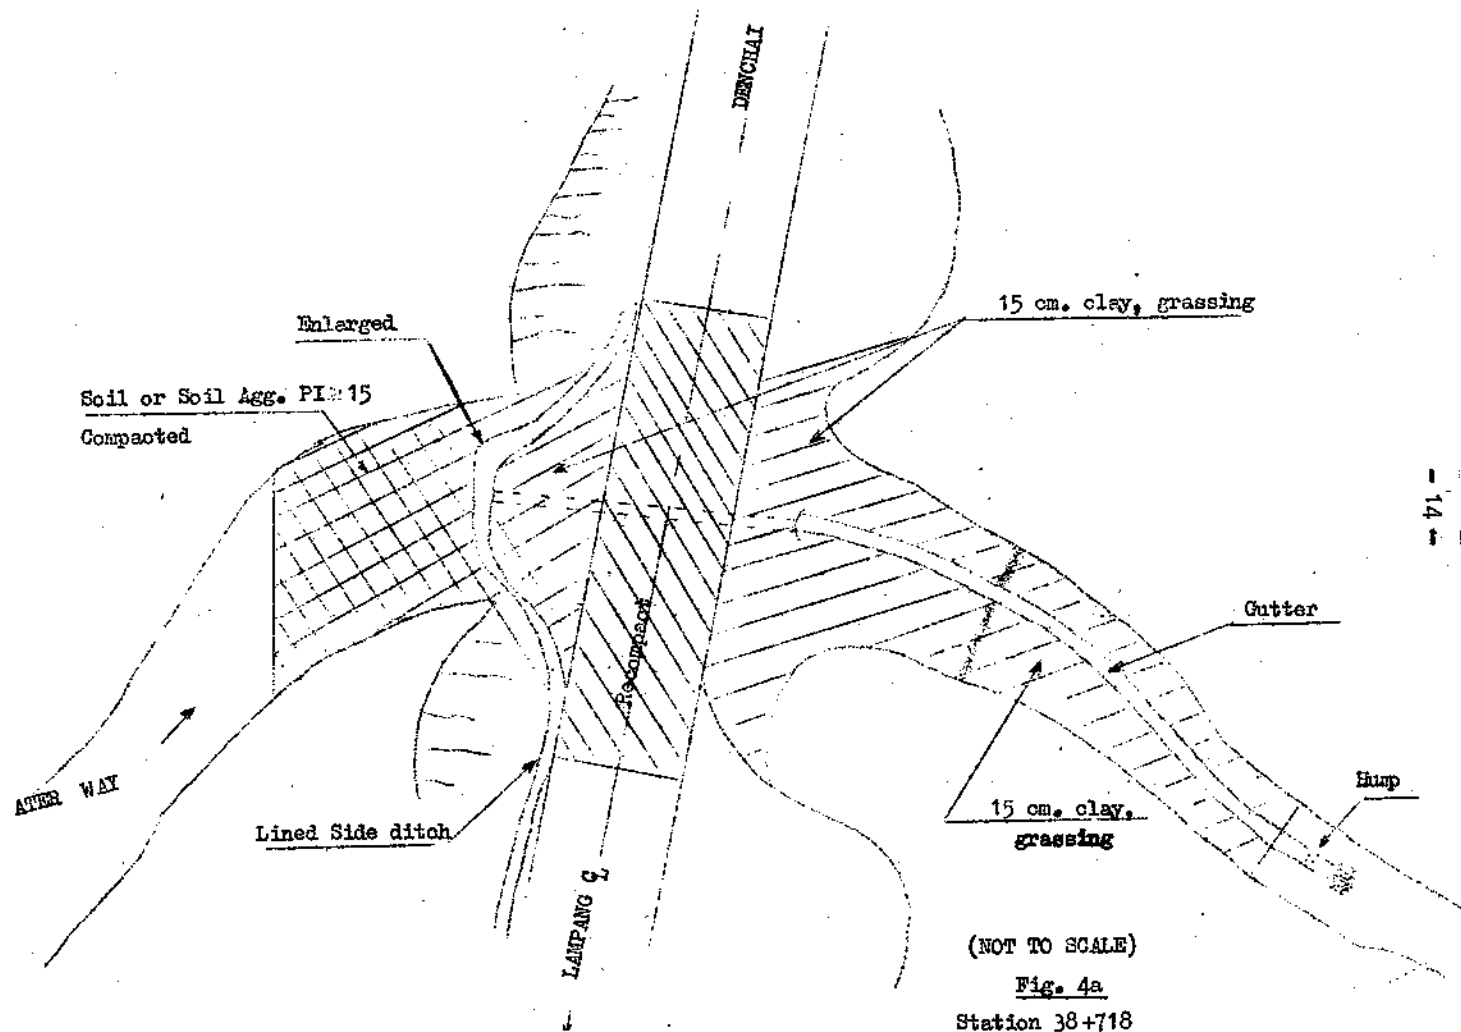
- Stations 38+718 (Figs. 4a and 4b).and 38+852 (Figs. 5a and 5b).

The two locations are similar in nature. Cracks and settlement were found at the portion of the embankment across the valley. Only at the station 38+718, the circular pipe is raised up above the original ground and the left hand side is filled with a berm embankment. With these situations an amount of water will caught at the left side of the embankment. The design is also similar to those previously mentioned. The only difference between the two station is the sand - rock layer at the toe of the top slope assigned at the station 38+718. The sand - rock layer is used to catch the small amount of water that may be able seep from the stored water at left side of the embankment.

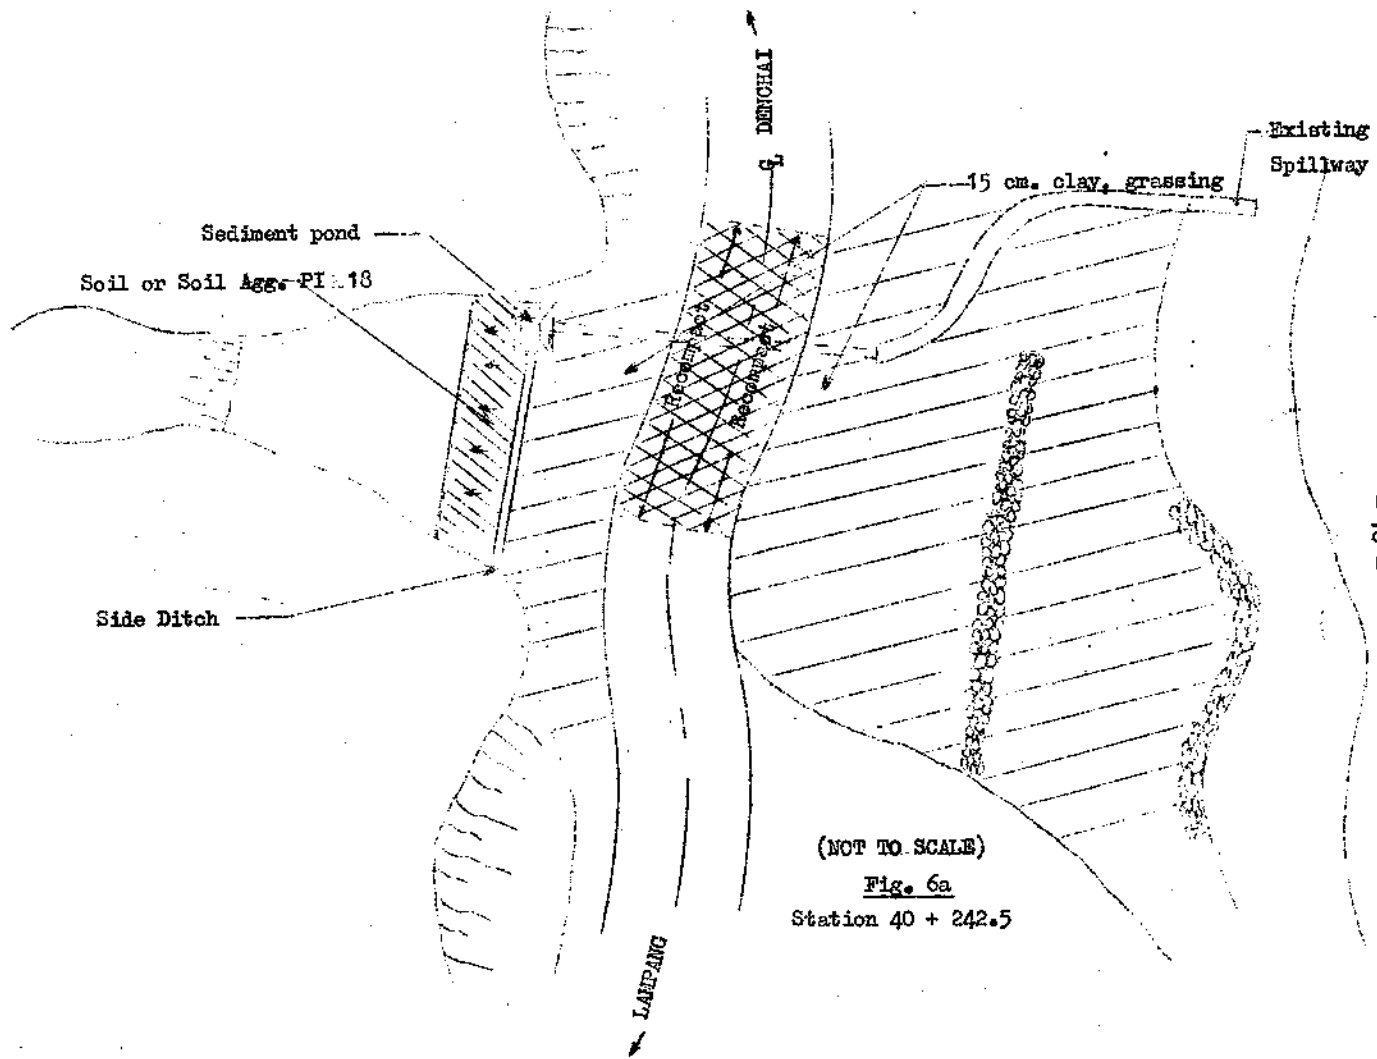
Fig. 6a

- Station 40+242.5 (Figs. 6a and 6b). This location is similar to the station 38+718. Only the amount of stored water is greater and the toe slope at the right hand side can be softened and scoured by the attached water way. The toe slope material is then replaced and covered with big rock. The gutter presented in the drafting is the existing one, and it should be avoid from any disturbance.

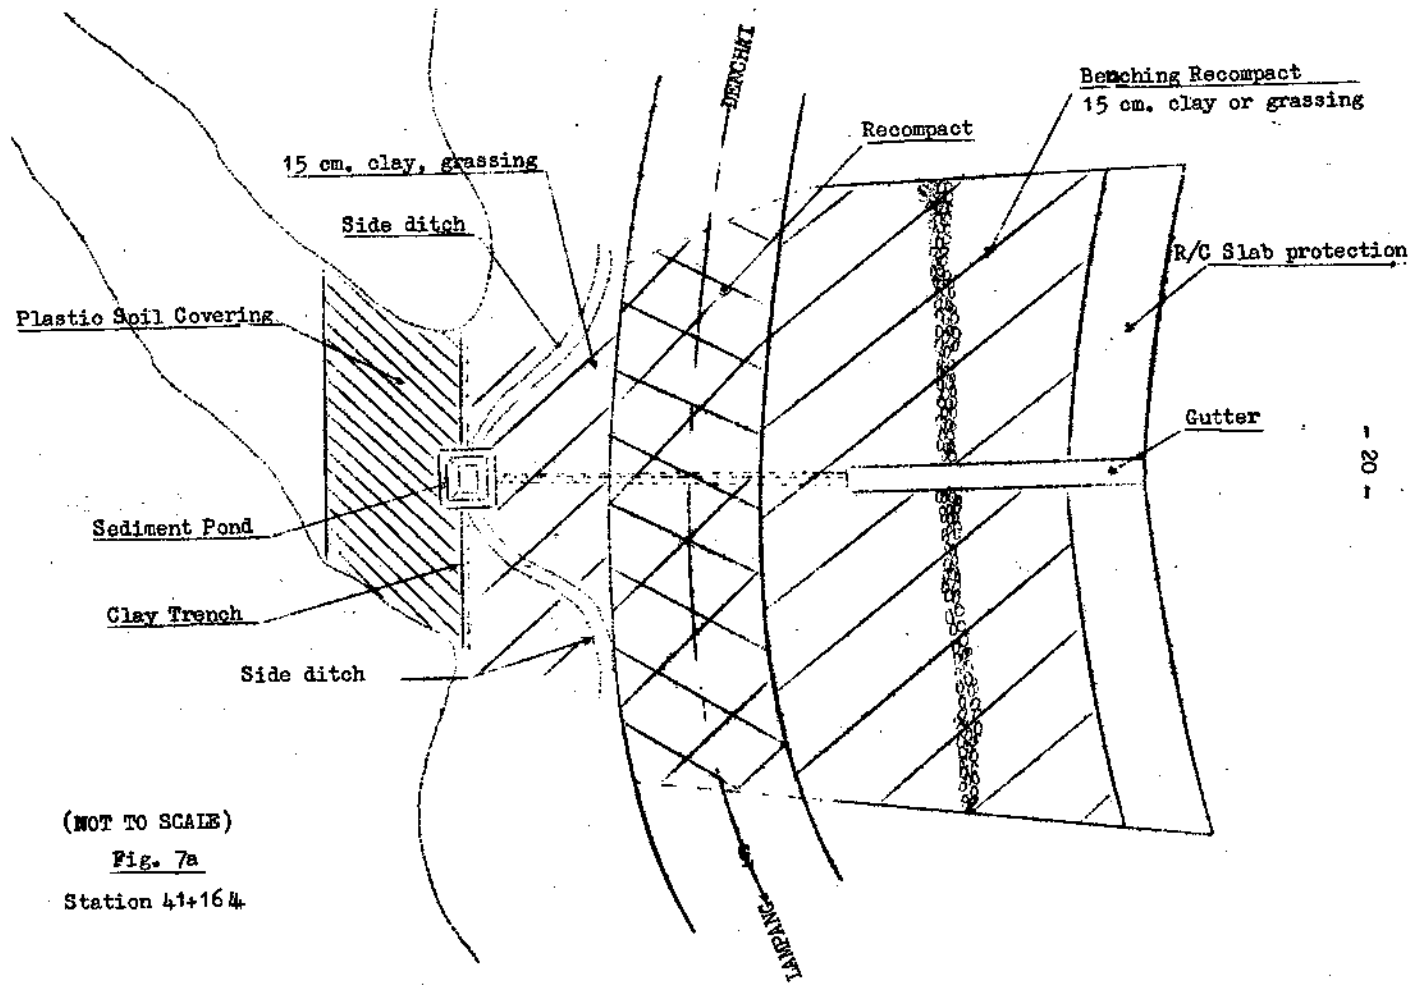
- Station 41+164 (Figs. 7a and 7b). It was found during the investigation that at this station the movement of the embankment caused severe damage to the right side of the embankment. Recompaction of the side is then assigned in the form of the step benching process as shown in the drafting. The R/C slab protection at the toe of the RRS slope will be able to protect the severe damage from the rushing water in the attached stream channel. The other assignments for the location are used for the purposes that are similar to those previously mentioned.
