REPORT NO. MR 34

AN INVESTIGATION OF SLOPE FAILURES  
IN THE NORTHERN PART OF THAILAND

DEPARTMENT OF HIGHWAYS , MINISTRY OF COMMUNICATIONS ,  
BANGKOK 4, THAILAND

Report No. 34  
Materials & Research Division  
Department of Highways  
June 1978

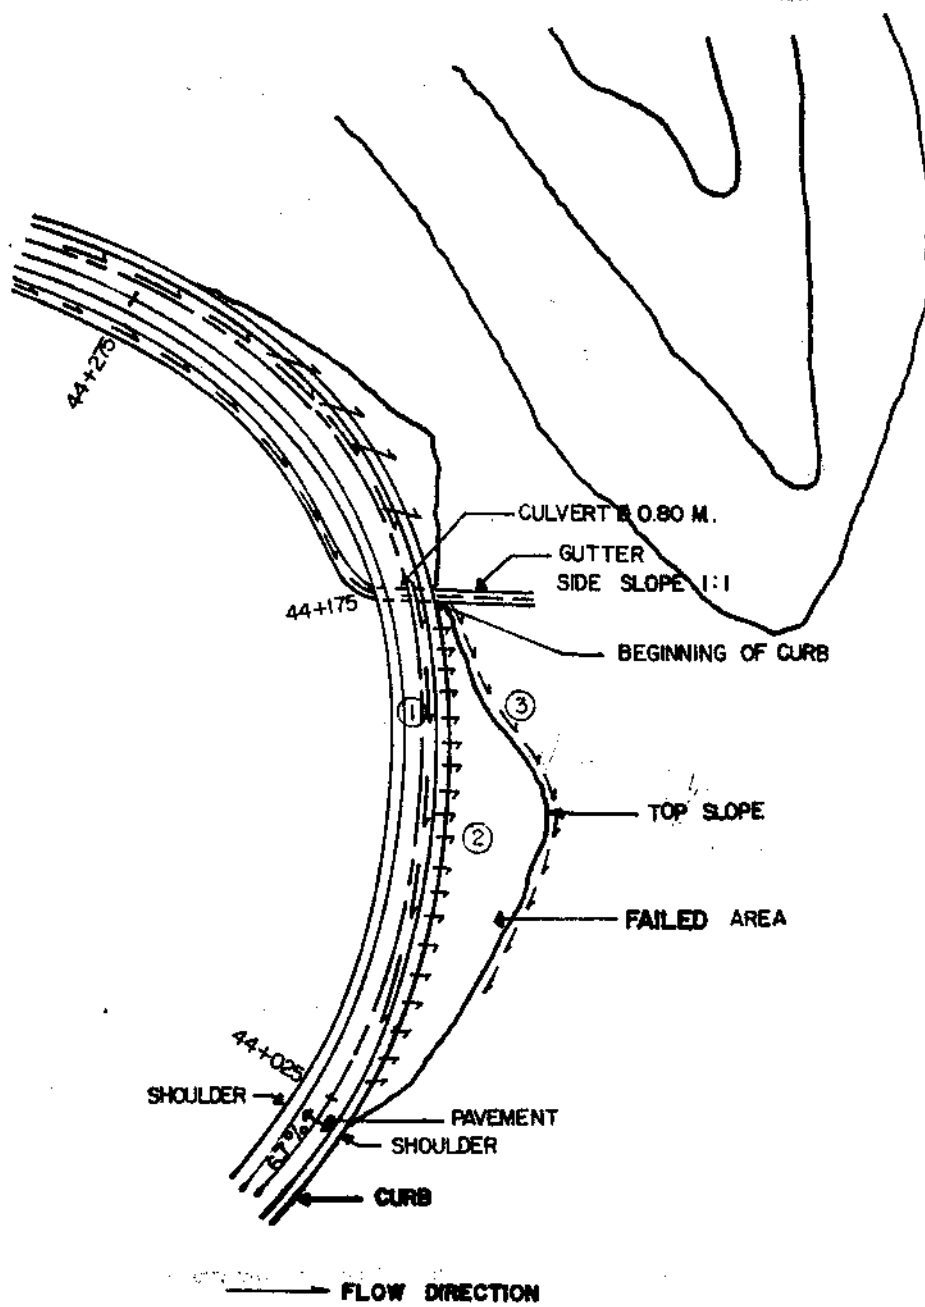
FIG.3 b POSSIBLE SURFACE WATER ( K.M. 44 + 100 )

Km. 44+100, Only three possible ways of surface water are expected at this station. They are surface water nos. (1), (2) and (3) with the same characteristic as explained in the previous station. It should be remarked here that the surface water No. (3) at this station which is now a running water that comes from the side ditch at the left side of the road and runs across the road in a circular concrete pipe, diameter 0.80 meters was drained out at the right side of the slope by a gutter as shown in the Figure 3b. Unfortunately, at the outlet end of the pipe, the amount of water was too large to be carried by the gutter. Overflow occurred at the location. The overflowing water scoured the supporting soil under the gutter and broke a part of the gutter and flowed down perpendicularly to the intended direction to the toe slope.
